# BELZONA 1391S APPLIED TO NEW CYCLONIC SYSTEM

ID: 9385

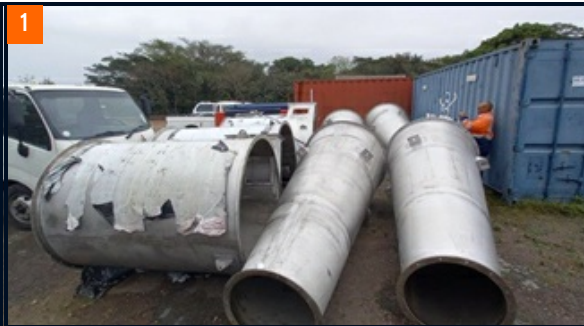
1. Newley fabricated cyclones ready for coating
2. Internals of the cyclones coated
3. Cyclone internals coated ready for delivery
4. Coating of Cyclones 1 & 2 - showing internal coating completed

Belzona 1391S was specified due to its ability to withstand chemical attack from the phosphoric acid, as well as the erosive nature of the lime powder/raw materials, and exposure to high temperatures. Belzona 1391S was applied using heated airless equipment as explained in the Information for Use Sheet.
