# REPAIR OF HOLED NOZZLES ON A VESSEL

ID: 9390

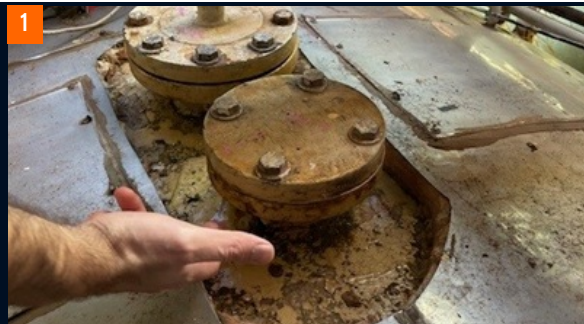
Customer had a process vessel containing a dangerous chemical during process which has faced severe corrosion at the nozzle joints.

1. Severe through wall corrosion at the base of the nozzles exposed dangerous chemicals during the process
2. Mixing Belzona 1212 in preparation for the repair
3. Application of Belzona 1212 over repair area with reinforcement plate/mesh to be fitted
4. Completion of the application coated with Belzona 5831

Repair area, which was originally coated and corroded was ground and clean back to bare metal exposed the hole on the tank/nozzle. Belzona 1212 was the product selected to bond and repair the area, due to inability to carry out any form of abrasive blasting.
