# BELZONA SUPERWRAP II PREPARES FOR THE WORST

ID: 9391

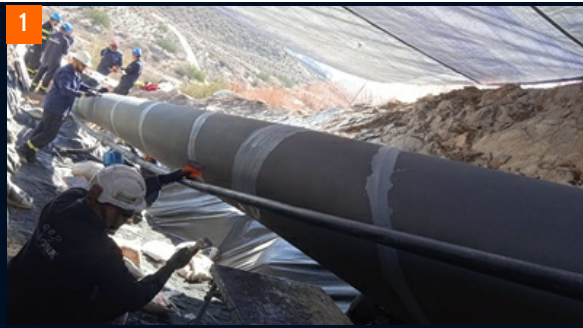
1. Application start, application of Belzona 1111 to spiral weld area to make a smooth transition
2. Application of Belzona 7311 plate bonds
3. Belzona SuperWrap II system
4. Completed application overcoated with Belzona 5811

The pipeline is expected to go through wall due to internal corrosion in the 5-7 o'clock position of the pipe at some point in its future, a method was needed to reinforce this area. The pipe was grit blasted to a SA2.5 and a 75 micron minimum finish, to which plates were bonded to the lower section of the pipe with Belzona 7311. This was then wrapped with Belzona SuperWrap II and finished with Belzona 5811
