# POWER STATION SEA WATER PIPE

ID: 9398

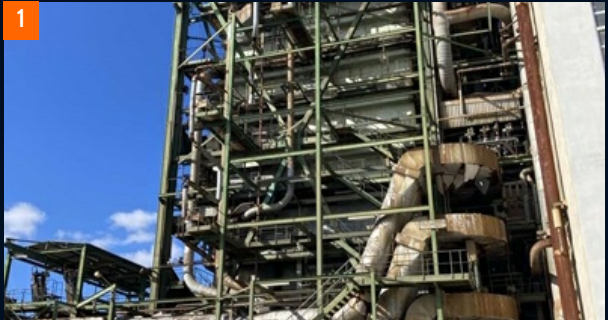
Facility had a leakage issue with a sea water pipe. They had applied tape to minimize the leak, which was not an adequate solution.

- 1. Facility view
- 2. Component initial condition
- 3. Surface preparation
- 4. Component repaired

Tape removal, substrate surface preparation, application of Belzona 1161 with reinforcement tape 9341 according to IFU.
