# BELZONA 4311 ON CHEMICAL CONTAINMENT AREA

ID: 9399

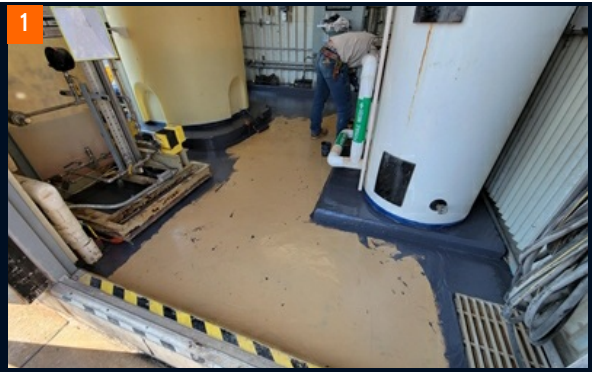
1. Beginning of the application
2. Application of first coat of Belzona 4311 gray
3. Application of second coat of Belzona 4311 red
4. Application complete

The floor was hand propped with angel grinders and diamond tip blades. After that it was cleaned and a first back coat was applied of Belzona 5811. After it was cured a two coat system was applied of Belzona 4311 gray and red.
