# BELZONA SHAFT REPAIR ON SUBMERSIBLE PUMP

ID: 940

Bore hole pump

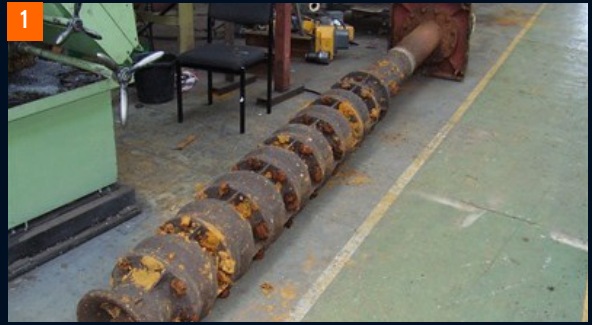
1. Pump unit complete
2. Shaft damage/wear
3. Machining following Belzona 1131 application
4. Completed repair

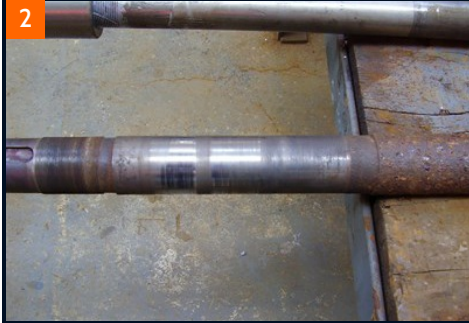
Damage to bearing surface caused by constant motion of phosphor bronze bushing

Belzona® 1131 chosen for self lubricating properties and most importantly - speed of repair
