# BELZONA REPAIRS WASTE WATER CLARIFIER BASE

ID: 9400

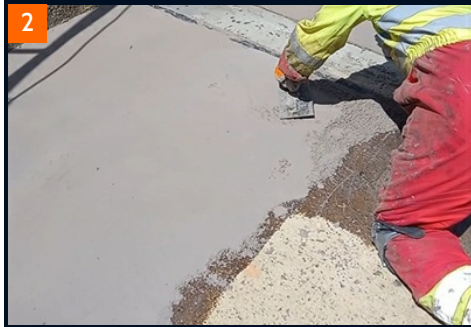
A waste water concrete clarifier had a worn uneven surface after years of harsh service. This meant the clarifier could not operate properly & waste sludge was collecting on the bottom of the tank.

1. Worn surface
2. Application in progress
3. Completed section
4. Finished application

The area was washed & abraded to get back to sound concrete. Any deep areas were filled with Belzona 4131 before the larger screeding application. 6mm of Belzona 4131 was then applied over the full base of the clarifier. Metal screed rails were used to control the thickness & maintain a constant level.
