# TUBE STACK FACES

ID: 9401

## PROBLEM

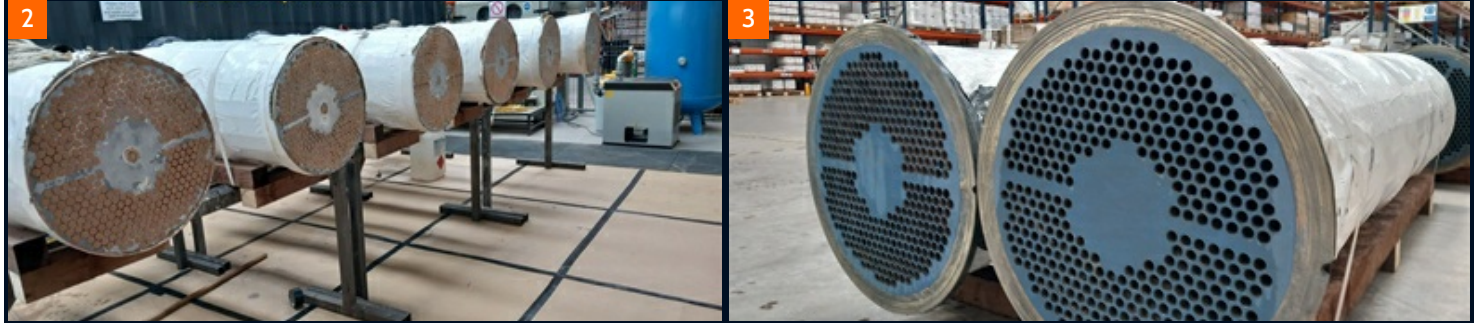
During the Planned Outage of the station, the tube stacks were inspected and due to sea water been used for cooling the faces were found to have significant erosion and corrosion.

1. Condition of the faces upon arrival at the workshop
2. A total of over 3000 corks where required for plugging the faces
3. Faces after coating

Grit Blast all faces to SA2.5 with a profile of 75 Microns.

Remove all debris.

Cork all holes.

Rebuild areas with 1311

Apply 2 coats of 1321 as per IFU
