# BELZONA SAVES THE SUMP

ID: 9405

## PROBLEM

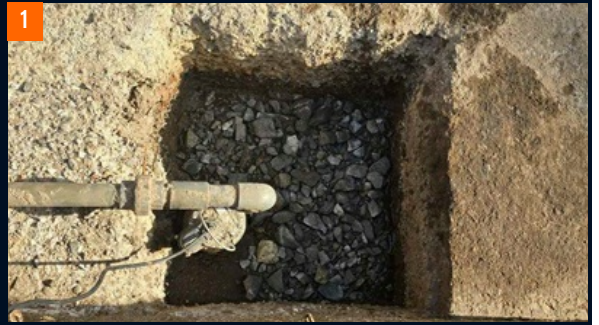
Chemical erosion had damaged this sump to the extent that there was no concrete left on the bottom of the sump, and the sides had major damage.

The concrete in this sump was heavily damaged by chemical erosion over several years. Upon cleaning it out it was discovered that the bottom of the sump was completely missing with only gravel and dirt remaining.

1. The sump in its original condition.
2. The sump after applying 3 buckets of 4111 to the bottom.
3. The sump with the plastic wrapped plywood former installed.
4. The sump after pouring a slurry mix of 4111 around the former. Application complete.
