# CONCRETE FLOOR REPAIRS

ID: 9406

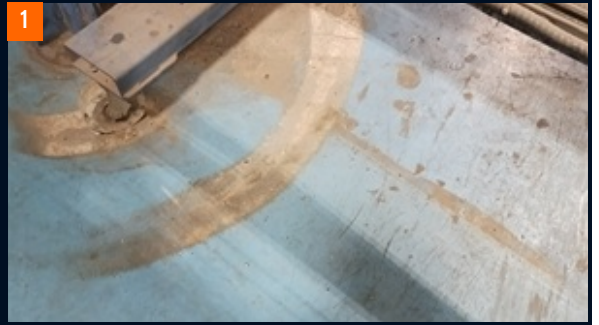
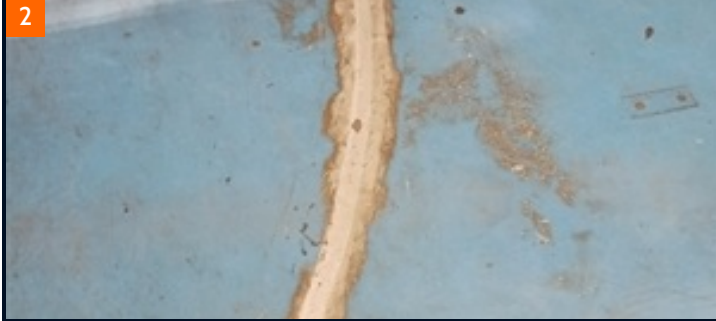
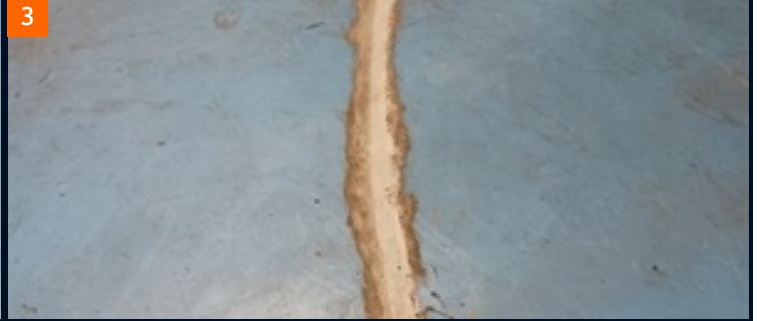
The customer was experiencing that their steel wheel conveyor system due to heavy loads were wearing grooves into the concrete floor.

1. Floor area showing where the grooves have been repaired on this conveyor.
2. Floor area showing where the grooves have been repaired on this conveyor.
3. Floor area showing where the grooves have been repaired on this conveyor.

Concrete floor at the moving conveyor production area was in need of repairs and the customer was in need of a quick fix.

Application was carried out using the Belzona System Leaflet FPA-1
