# BELZONA BLOCKS THE LEAKS IN SECONDARY CONTAINMENT

ID: 9407

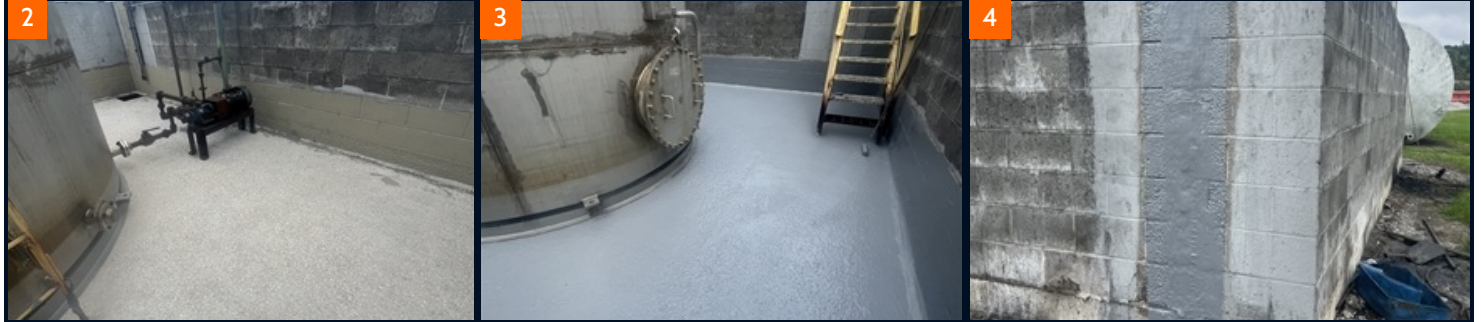
## PHOTOS

The secondary containment had formed some cracks over time in the block wall and where the concrete meets the wall.

1. Grit blasting the floor to get correct surface profile.
2. Area after grit blasting
3. Floor after the second coat
4. The crack in the outside of wall that was repaired with Belzona and coated

Abrasive profile/Eco-Blast all areas that were to be coated. Rebuilt damaged area with Belzona 4124 and coated two coats of Belzona 5811. Block wall with cracks were filled with Belzona 4111, coated with Belzona 5815 with 9341 reinforced system,
