# BELZONA PROTECTS GRP WATER TANKS

ID: 9414

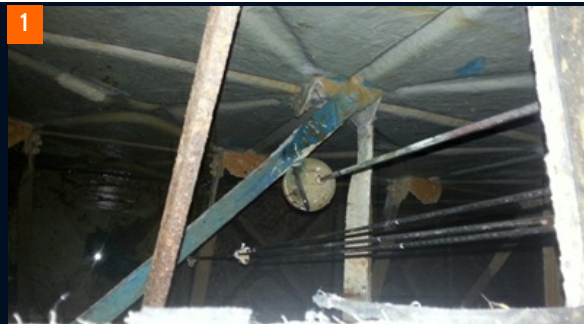
Two GRP cold water storage tanks were in need of relining to protect the substrate & bring up the hygiene standards of the tanks.

1. Before internal
2. Complex geometry
3. During inspection
4. Completed application

The tanks were grit blasted to clean & prepare the GRP substrate. Two coats of Belzona 5811 DW2 were then applied.
