# BELZONA STEP NOSING REPAIR

ID: 942

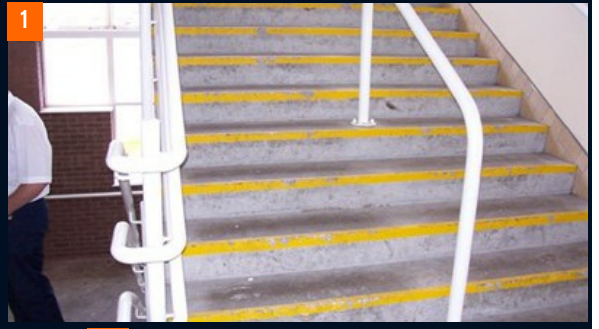
Porters had been bouncing beer barrels down the steps from the bar situated on the floor above. This was damaging the concrete step nosings.

1. Steps showing signs of damage
2. Close up of damage
3. Steps repaired
4. Close up of repair
