# PROTECTION OF THE INSIDE OF THE FILTER HOUSING.

ID: 9421

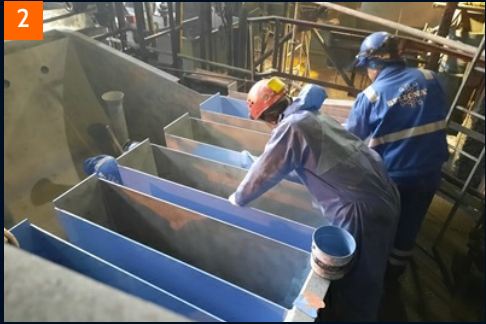
Abrasion and corrosion occur during filter operation. The rotor on which the inflatable canvas discs are located, scoops up the sludge on its surface at the bottom of the filter and then rubs it into the overflow channels at the top.

1. Before applying the Belzona product, the surface was blasted.
2. Application of the first layer of Belzona 1341.
3. Application of the second layer of Belzona 1341.
4. Application of the second layer of Belzona 1341.

The surface was cleaned, blasted and coated with Belzona 1341.
