# ACCURATE ALIGNMENT OF MACHINERY

ID: 9422

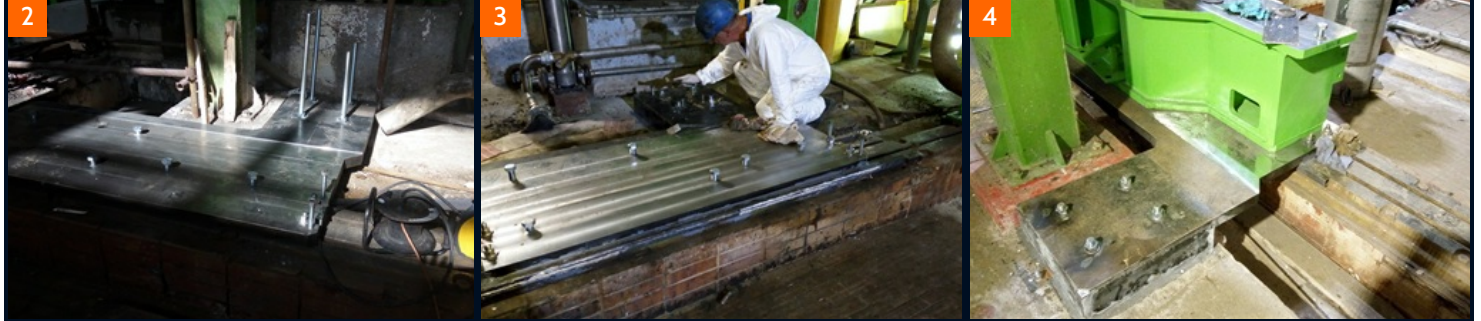
1. A device that needed to be stabilized.
2. Height adjustment of all surfaces.
3. The application of Belzona 5811 .
4. The application of Belzona 5811 .

The application of Belzona 5811 composite was carried out using pressurized injection cartridges. This allowing a quick application and return to service.

Undercoating with Belzona 5811 was faster and cheaper than using construction mortars.
