# SILO CONE GAP SEALING

ID: 9424

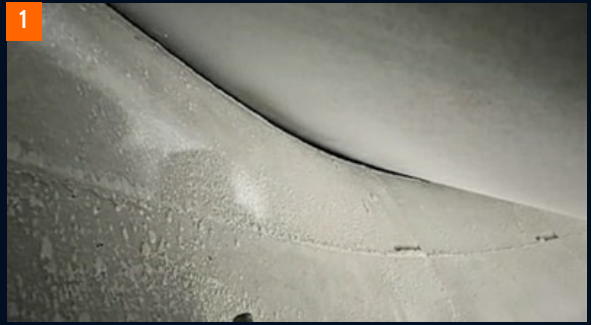
White cement was falling off from a gap between the silo cone and the concrete wall which poses safety concerns for the employees.

1. Gap between Silo cone before cleaning
2. Gap before surface preparation.
3. Gap after sealing with Belzona 1111.
4. Final sealing with Belzona 1111.

A blower was used to remove cement from the surface and surroundings. Belzona 91111 was used to clean the surface. Belzona 1121 was then injected using Belzona pneumatic pistol into the gap to seal off the falling materials. Additional material was applied using Belzona applicator to make sure the area is well sealed.
