# BADLY DETERIORATED PROCESS TANK DUE TO EROSION CORROSION AND HIGH ALKALINITY REFURBISHED BY BELZONA.

ID: 9425

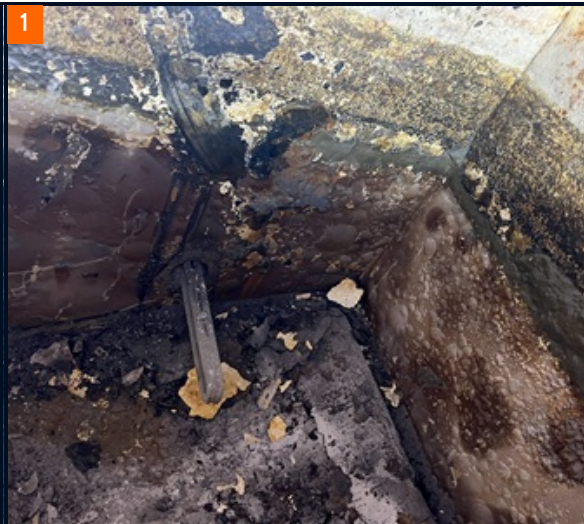
Process tank was in a deplorable state after years of wear due to erosion corrosion.

1. Tank before surface preparation.
2. Tank after surface preparation and rebuilding with Belzona 1121.
3. After wrapping top part of tank with superwrap II, the internal is being coated with Belzona 1341.
4. Tank External after coating with Belzona 5811.

- Tank was cleaned using a power tool and a cleaner/ degreaser.
- Internal of the tank was rebuild with Belzona 1121.
- The worn part at the top was reinforced with Belzona superwrap II.
- The internal was then coated with Belzona 1341 and external with Belzona 5811.
