# BELZONA 5871 INSULATES AMMONIA PIPES

ID: 9426

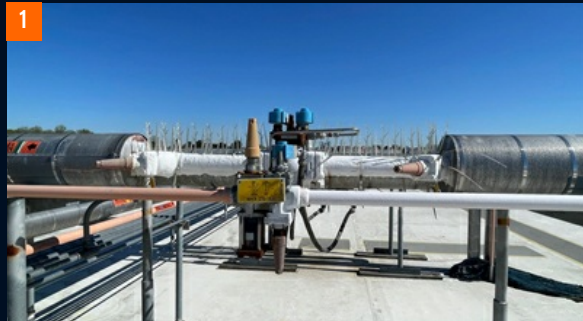
This Distribution Center roof housed between 50 and 60 ammonia pipes. Due to moisture on the pipes, birds were pecking at the original coating and insects were getting stuck. This resulted in the maintenance team having to re-apply the coating every year.

1. Ammonia pipes
2. Cladding removed
3. Belzona 5871 applied
4. Belzona 5871 applied
