# TREATMENT OF THE INNER SURFACE OF THE SCRUBBER

ID: 9429

## PROBLEM

Corrosion, erosion of the inner surface of the blast furnace gas scrubber.

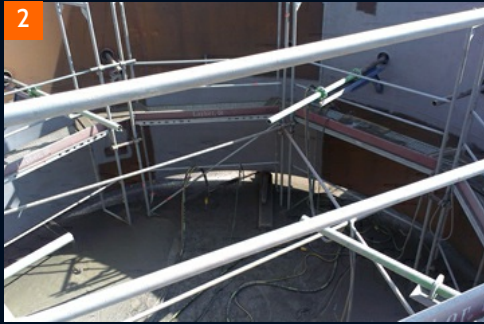
1. Overall view of the scrubber.
2. The surface had to be blasted for application.
3. Application of the first layer of Belzona 5811.
4. Application of the second layer of Belzona 5811 product.

Blasting and spraying of Belzona 5811 in parts during an overhaul.
