# BELZONA WEATHERPROOFS BALCONY

ID: 943

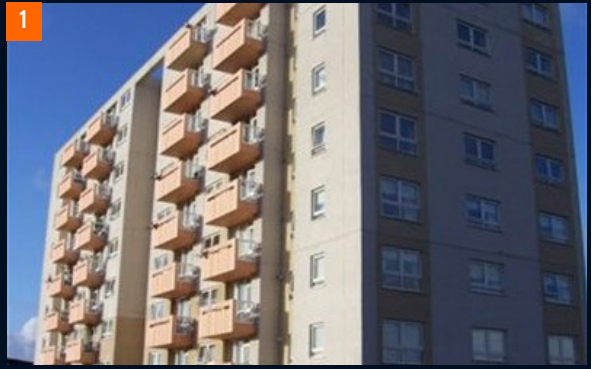
Water was finding its way into the flats from the balconies. Customer needed a weatherproof and non-slip solution.

1. One of the three blocks of flat
2. Loose asphalt being removed
3. Belzona 3131 being applied
4. Aggregate being scattered onto top coat of Belzona 3131
