# TREATMENT OF THE ZINC SLUDGE TANK.

ID: 9430

Abrasion, corrosion of the zinc sludge sedimentation tank.

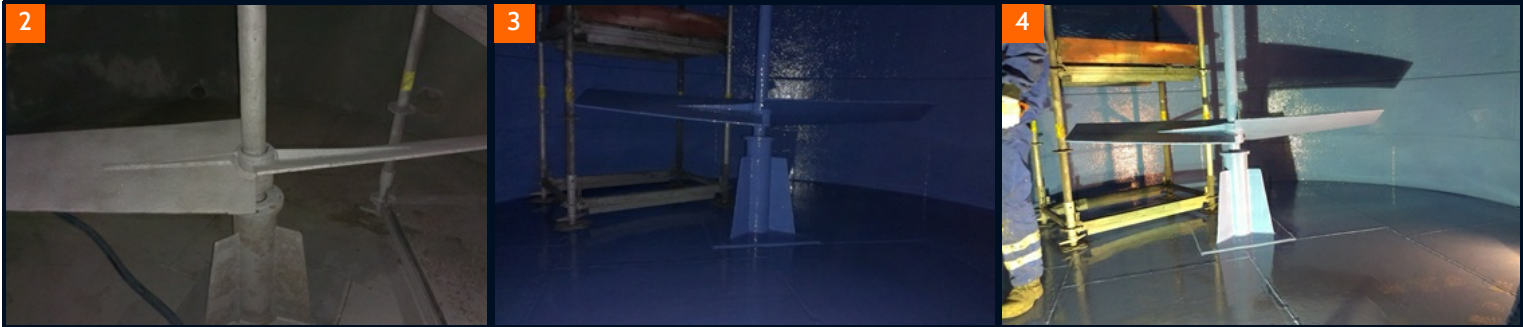
### PHOTOS

1. Damaged tank.
2. Tank after blasting.
3. Application of the first coat of Belzona 1341.
4. Inspection of the coating after the application of the second coat of Belzona 1341.

The inner surface of the tank was blasted, larger irregularities filled with Belzona 1311 and then covered with two layers of Belzona 1341

Filling the damages with Belzona 1311 and then coating twice with Belzona 1341 was a quick and cost-effective solution for the customer.
