# BELZONA 3412 FLANGE PROTECTION SYSTEM

ID: 9431

EDF ENERGY HEYSHAM LANCASHIRE

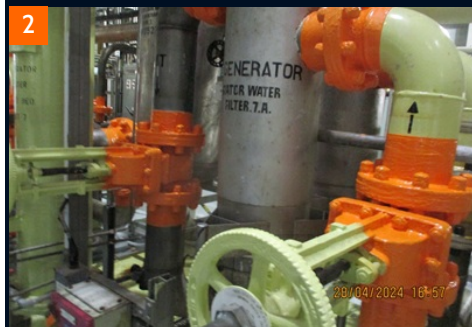
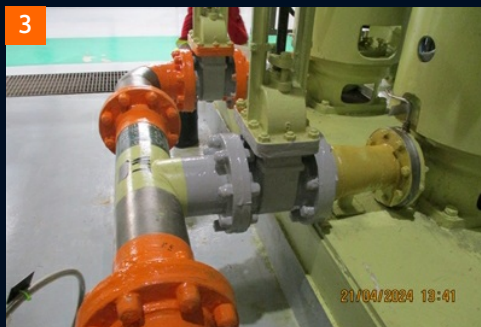
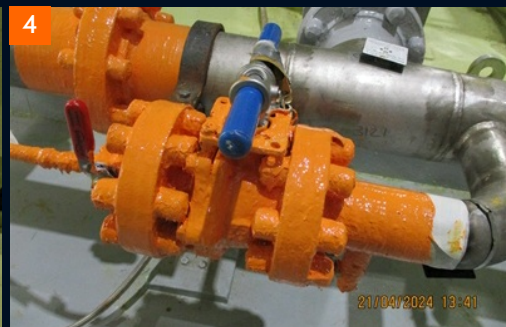
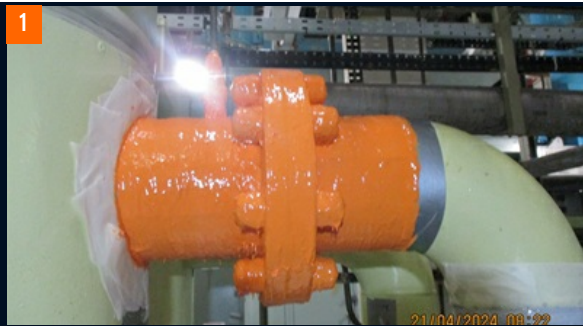
Altrad services coating department were recently approached by EDF Energy to assist with encapsulating approximately 140 flanges to the turbine stator water system. The flanges were being encapsulated due to air being drawn into the system, from the vacuum side of the stator water. These levels were higher than normal, so rather than taking the full system or unit out of service, Belzona 3412 would be used for the task, until the system could be brought out of service for maintenance.

1. FLANGE & FASTENINGS PROTECTION
2. 2 X COAT SYSTEM OF BELZONA 3412 PROTECTING FLANGE GASKET AREAS AND FASTENINGS.
3. MULTIPLE FLANGES SHOWING FIRST & FINAL COAT APPLICATIONS.
4. BELZONA 3412 CAN BE APPLIED TO ALL GEOMETRIES AND SEAL THE FLANGE AND FASTENINGS, EASY INSPECTION AND RESEAL.

The cost of Belzona 3412 system is not prohibitive as in this case we have sealed the leaks and added protection to the substrate, inspection is easily done by peeling back the Belzona 3412 and resealing after maintenance.

Application surface prep, done with emery cloth making sure all surface were clean and any debris removed, the application as per the IFU was carried out without any problems.
