# PVC CHILLER INTERNAL REBUILD W/ BELZONA 1121 AND BELZONA 1321

ID: 9432

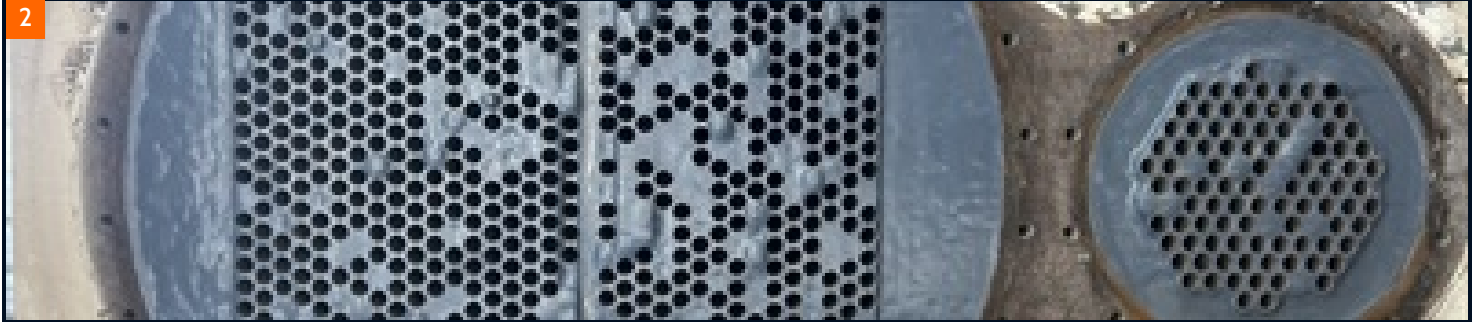
1. Before Repair
2. After Repair

Client found extreme corrosion and had minimal down time for repair.

Abrasive blasted entire areas to be coated to SSPC SP 10 as per product manufactures recommendations.

Rebuilt damaged internal areas as identified with Belzona 1121

Coated all internal wet areas identified with Belzona 1321 Ceramic S Metal
