# AMMONIUM SULPHATE FEED TANK RESTORED WITH BELZONA SUPERWRAP II

ID: 9434

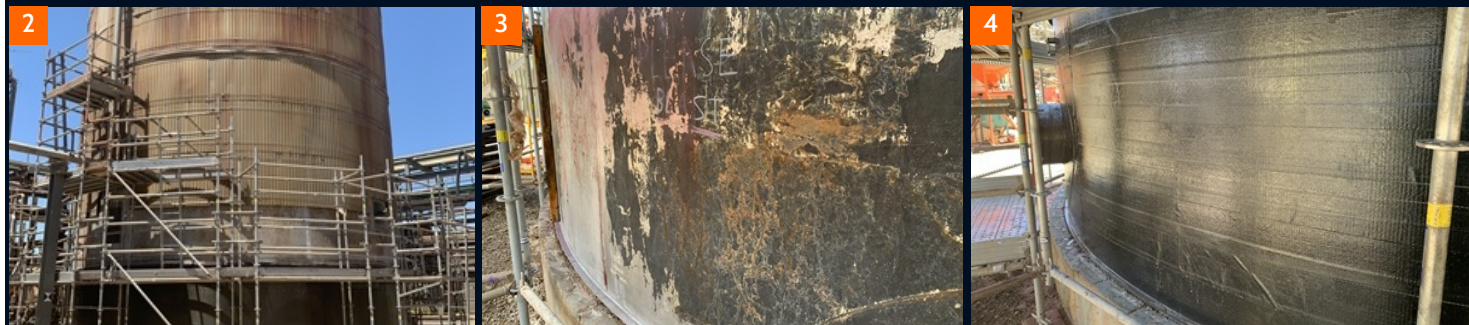
The Customer's stainless steel feed tank was suffering from corrosion under insulation and chloride induced stress corrosion cracking.

1. Corrosion under insulation on an ammonium sulphate feed tank
2. Composite wrap system curbs corrosion under insulation at nickel mine
3. Corroded tank in need of long-term repair and protection
4. Stainless steel feed tank repaired and protected

Firstly, all traces of oil and grease contamination were removed using a suitable Rezitech Degreaser. Following this, the surfaces were grit-blasted to provide a surface cleanliness compliant with ISO 8501-1 SA 2½ (ASNZ 1627.4 class 2.5) with a minimum 75 µm (3 mil) rough angular profile.

Once the surface was prepared, the Belzona 9381 reinforcement sheet was measured out and then wetted out with the Belzona resin system. The resin was then systematically applied to the areas to be repaired. Following this, the Belzona reinforcement sheets were then applied to the tank in three layers. The compression film was then added to the top of the application area. Next, using a roller, the Belzona SuperWrap II composite wrap system was then spread, rolled and compressed to the surface of the tank. The system was then left to cure for approximately eight hours.
