# REPAIR OF DAMAGED FLOWING PARTS OF THE TG4 STORAGE PUMP

ID: 9435

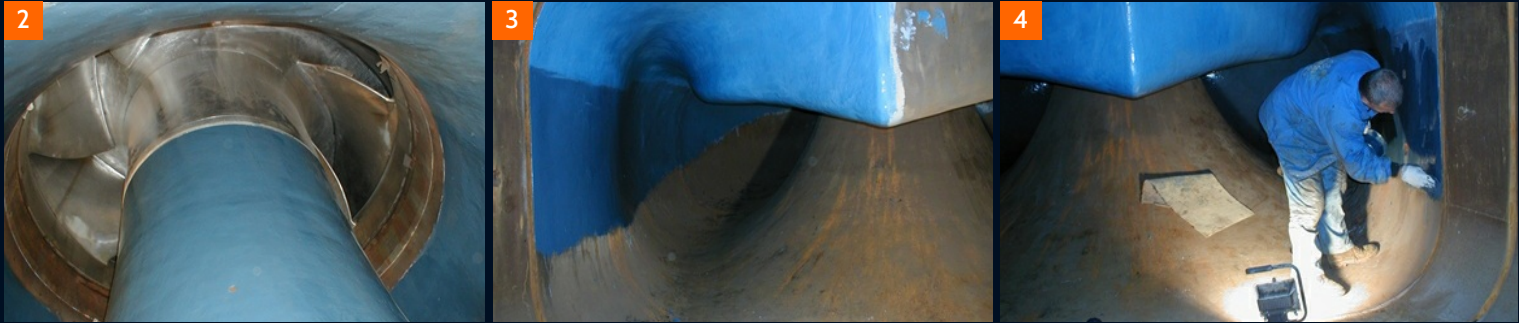
Damage to the pump surface by cavitation and the formation of a rough surface.

- 1. View from the outside
- 2. Belzona 1341 application
- 3. Belzona 1341 application
- 4. Belzona 1341 application

Sealing of the working space under the impellers of the first stage. Drying of the repair area, degreasing of the surface with BELZONA 9121. Blasting of the repaired surfaces to the required standard Sa 2.5 with extraction cleaning of the space and dedusting of the area. Local repair of places and areas where the base material has been lost with BELZONA 1311 Ceramic R Metal. Application of BELZONA 1341 Supermetalgilde to the surface to be repaired in two coats with a thickness of min. 500 µm.
