# LAEIS PRESS – REPAIR AND MACHINING OF THE OUTER SURFACES OF THE Ø 1200 PISTON

ID: 9437

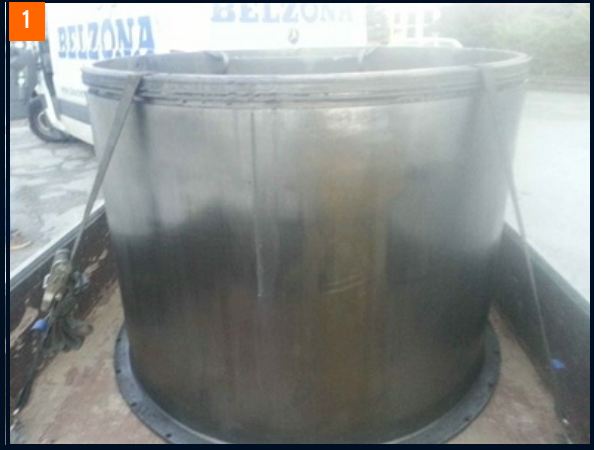
The outer surface of the piston was damaged by grooving. Grooves were created during the operation of the device by unintentional ingress of the product into the inner space of the cylinder.

1. Damaged cylinder surface.
2. Centering of the piston in the machining device, turning the surface around the entire circumference to a depth of 1.6 mm.
3. Application of BELZONA 1311
4. Final grinding and polishing of the surface to the nominal dimension and surface roughness
