# REFURBISHMENT OF A MARINE CAISSON

ID: 9439

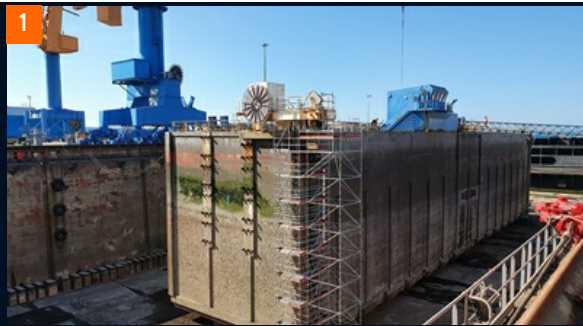
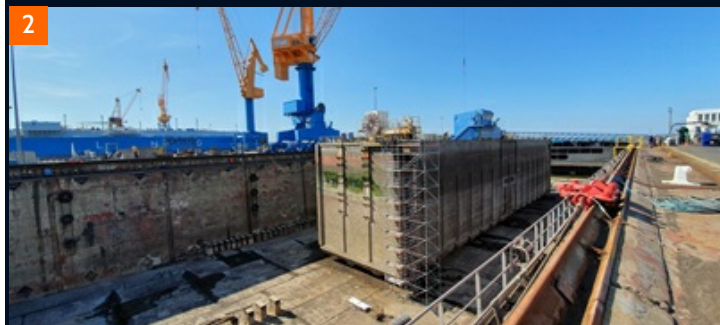
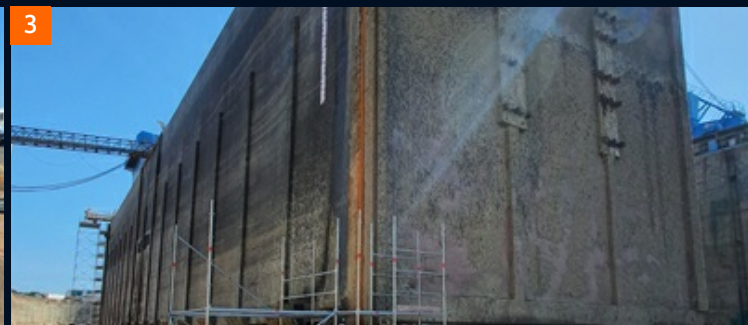
This caisson was suffering from significant corrosion, leading to an ineffective seal. The two steel installation surfaces (18000 x 1100 mm), sealed in the concrete of the boat-carrier, were completely corroded and damaged. The surface condition no longer made it possible to obtain full waterproofing when installing the louver closing seal. The client hadn't found a long-lasting solution for this structure other than applying two coats of paint every year when the tides were high. Welding new sheets was also impossible due to the deformations suffered and the lack of flatness obtained.

1. Caisson before the Belzona repair
2. Caisson before the Belzona repair from a different perspective
3. Caisson after the Belzona repair
4. Caisson after the Belzona repair

The client was responsible for setting up the scaffolding and washing HP and salt away for saline decontamination. Alliatech could then begin the application with sandblasting (SA2.5 /75µ roughness) and application of Belzona 5811 in 250µm to prevent corrosion before rebuilding with Belzona 1111. For final protection, two coats of Belzona 1331 were applied with a brush.
