# BELZONA WEATHERPOOFS POROUS STONework

ID: 944

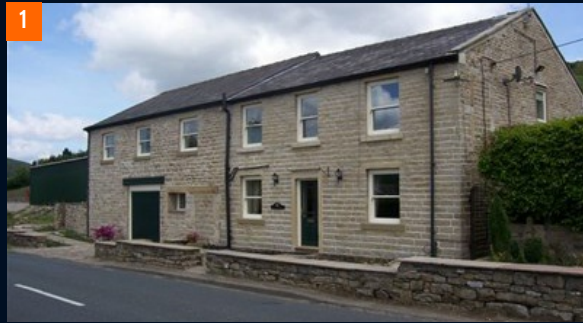
House had been recently renovated and sand blasted externally. This process removed the weatherproofing properties of the stonework and as a result moisture was penetrating into the house.

1. View of property
2. Windows masked up and ready to go
3. Applying Belzona 5122 with spray unit
4. Application close up
