# CONCRETE REPAIR IN WASTEWATER CLARIFIER

ID: 9442

## PROBLEM

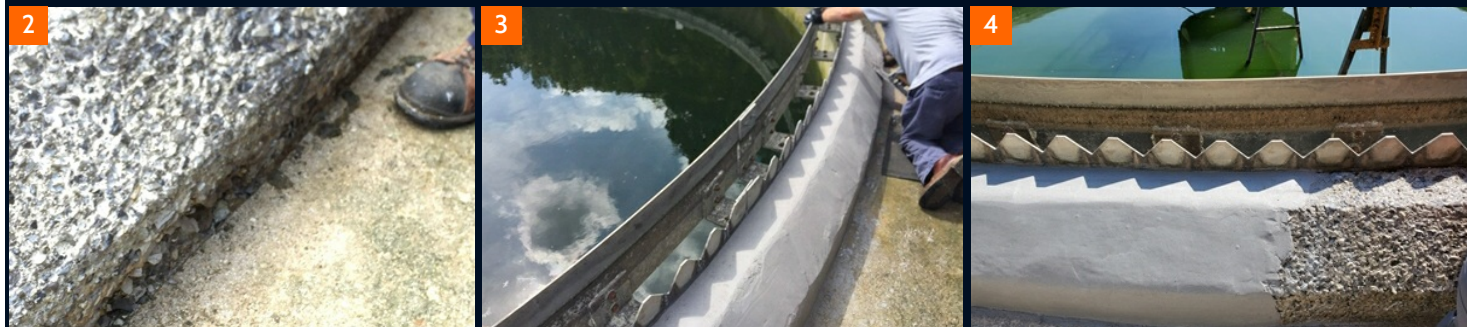
The Clarifier was suffering from damage to the concrete due to the age of the Clarifier and constant water and chemicals. Instead of replacing they chose Belzona. We have completed 4 out of 6.

1. Constant water running over the weirs has caused damage to the concrete
2. Damage after it was cleaned.
3. Applying Belzona 4131
4. Before and after.

Clarifier was pressure washed and any loose concrete was removed Belzona 4131 and conditioner was applied according to IFU.
