# CHEMICAL CONTAINMENT AREA

ID: 9443

## PROBLEM

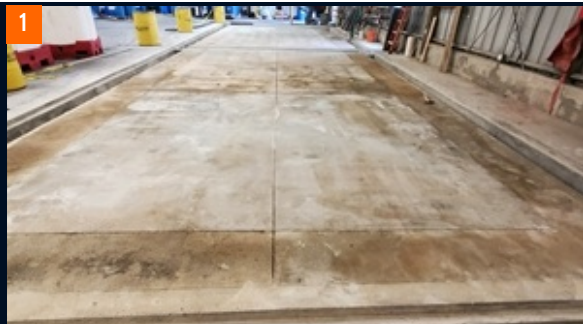
1. New uncoated containment area
2. The first coat of Belzona 4311
3. The second coat of Belzona 4311
4. Follow up picture

The new concrete was over 30 days old. It was pressure washed and allowed to dry then a grinder was used to give a profile on the concrete, It was cleaned again to remove the dust. Belzona 4911 primer was applied, then Belzona 4311 second coat of Belzona 4311 Grey followed Red.
