# BELZONA 1212 STOPS THE LEAKING PAN

ID: 9446

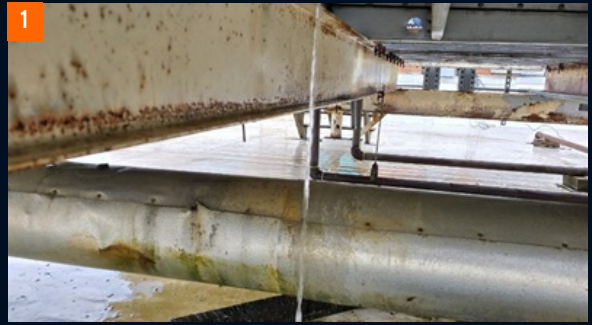
The water pan on their air handler developed a series of holes with the largest one about 3/4" in size and were losing gallons of water by the minute.

1. The constant stream of water leaking from the largest hole.
2. The hole from the top side of the pan.
3. The large hole covered with Belzona 1212 and some reinforcement metal.
4. This Belzona 1212 and reinforcement metal is covering about 6" of moderate size pinholes.

Coarse alumina oxide wet/dry sandpaper was used to prep the surface and remove the corrosion as the application area was under 8" of water. The reinforcement metal was roughened and cleaned, and a liberal amount of Belzona 1212 was applied to both the surface of the pan and the plate. The plate was then pushed firmly into place until excess material had appeared from all sides showing that full contact was achieved.
