# BELZONA SALVAGES AN AQUARIUM PUMP INTAKE

ID: 9449

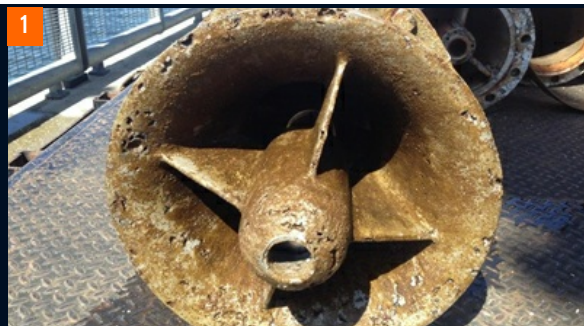
This salt water intake pump had heavy erosion, suspected to be caused by galvanic corrosion.

1. Original condition when removed from the salt water.
2. Grit blasted and ready for Belzona 1111.
3. Belzona 1111 applied.
4. Protected with two coats of Belzona 1341N.
