# BELZONA PROVIDES LONG TERM PROTECTION AGAINST UNDER FLOOR CORROSION

Carbon steel Paraxylene storage tank.

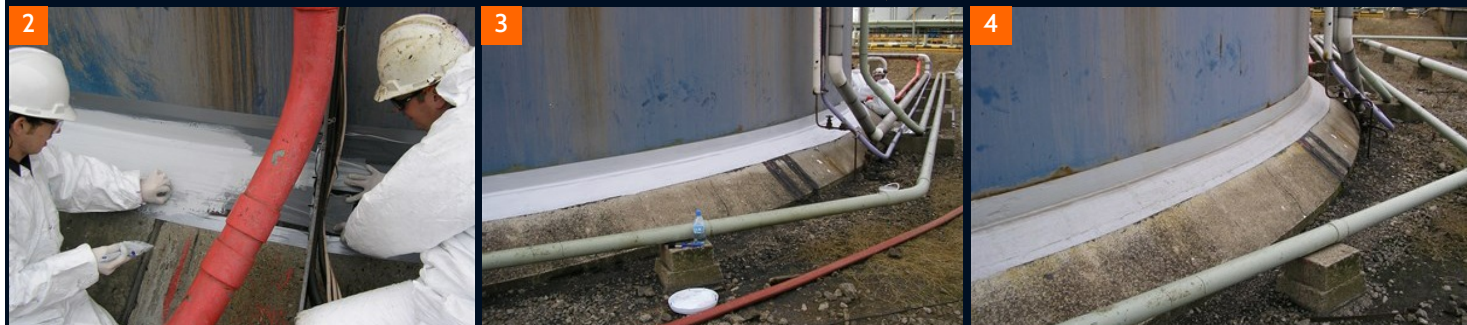
## PHOTOS

1. Before application of the Belzona system after new floor fitted
2. Application in progress
3. Application complete
4. Completed application over 2 years later

As a result of water ingress through the mastic type seal, under floor corrosion had occurred to an extent that the floor needed replacing. The customer was looking for a longer lasting, more effective base seal to satisfy government agency requirements.

The application was carried out in accordance with Belzona Know-How System Leaflet GSS-3
