# BELZONA 1111 AND 1341N REPAIR THE SPIDERS

ID: 9450

Heavy erosion to the spiders that support the shaft on a vertical multi-stage pump.

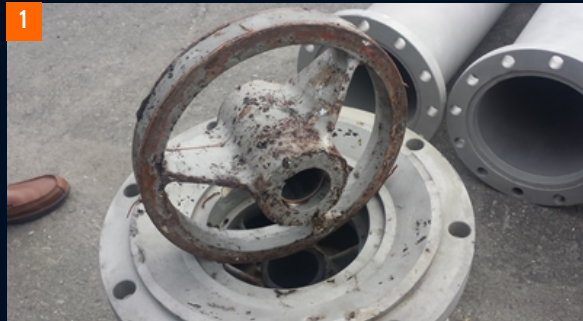
1. Original condition.
2. Grit blasted and ready for rebuilding.
3. Belzona 1111 applied.
4. All six spiders completed with two coats of Belzona 1341N.
