# BELZONA PROTECTS AGAINST IMPELLER WEAR

ID: 9453

## PROBLEM

This wastewater impeller was suffering from abrasive wear.

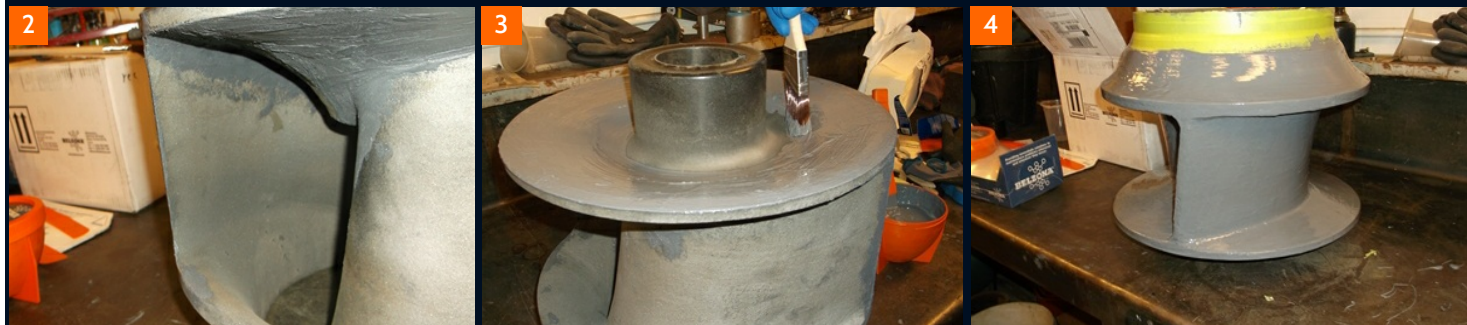
This impeller was showing the early stages of abrasive wear from wastewater solids. The customer wanted to repair the damage, and protect it from further damage. For only a couple hundred USD, this impeller was protected and returned to service in two days.

1. Showing some of the wear.
2. Belzona 1311 applied.
3. Applying the first coat of Belzona 1321.
4. First coat of Belzona 1321 complete.

The impeller was grit blasted in the customers blasting booth and rinsed of with acetone solvent before applying the Belzona 1311. Once the Belzona 1311 was firm enough, the first coat of Belzona 1321 was applied, and after a couple hours (per the Instructions For Use) the customer applied the second coat of Belzona 1321.
