# BELZONA 4111 REFURBISHES THE BALL MILL ENDS

ID: 9454

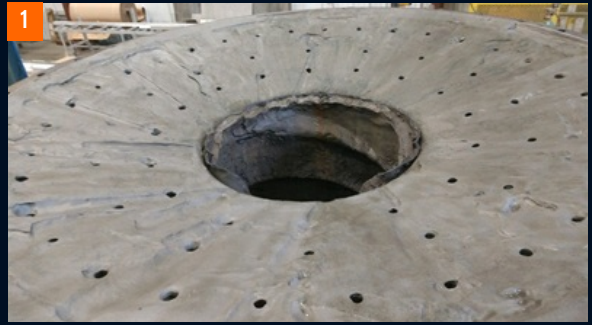
The ball mill ends had heavy wear and erosion.

1. Showing the damage to the surface.
2. Backer rods inserted into the wear plate mounting holes and showing the target profile height.
3. Applying Belzona 4911 Conditioner in the background, and applying Belzona 4111 using a guide to achieve the proper profile.
4. Belzona 4111 application complete.
