# BELZONA 4111 MAKES FOR A SMOOTH FLOOR

ID: 9455

## PROBLEM

This older metal casting facility had a lot of damaged areas on their concrete floor.

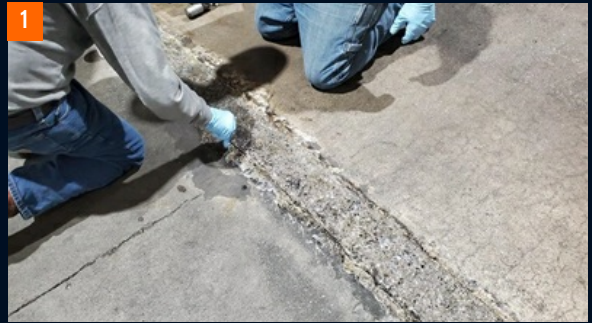
1. One of the damaged areas in a doorway.
2. Damaged doorway area repaired.
3. Showing several areas of damage near a machine.
4. Several damaged areas repaired.

The damaged concrete areas were prepped with a hand grinder and wire wheel to remove all loose material and roughen the surface. The Belzona 4911 conditioner was applied with a short bristled brush, and the Belzona 4111 was applied by hand, pushed firmly into the repair areas, and finished with a steel trowel.

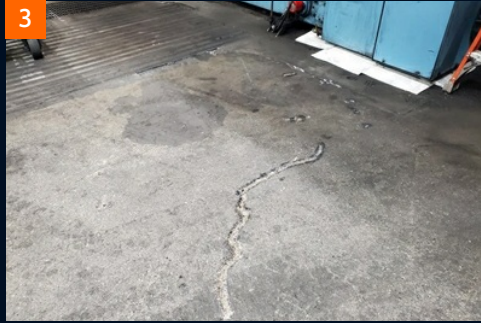
Other concrete repair materials had been tried, and all had failed. The damaged areas were causing trip hazards, and making it difficult to push wheeled carts over the floor. The Belzona 4111 solution allowed the customer to address many different areas from small divots to large cracks and areas where previous walls had been removed leaving deep areas of damage. Being able to do the application during their one day shutdown and return to service well before the plant began to operate was a huge positive for their maintenance team. They also liked the simplicity of the application process, and that there is no chemical/solvent smell when mixing and applying the Belzona materials. The ease of application also allows them to do further concrete repairs as needed on a more regular basis. Checking back with the customer 6 months later showed all of these repairs in perfect condition, and many other areas that they have repaired themselves since.
