# BELZONA 1111 FIXES PITTING ON A WICKET GATE

ID: 9456

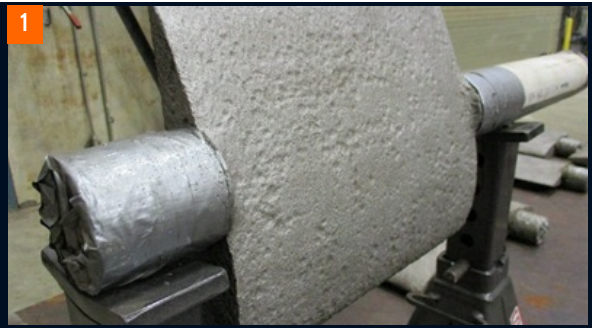
Full spread corrosion and erosion on the body of these wicket gates.

1. Pitting on the face.
2. Pitting on the end.
3. Applying the Belzona 1111.
4. Application completed on this wicket gate.

The customer had a nice sand blasting booth on-site, and were able to use alumina oxide to achieve a 3-5 mil profile. Once blasted, they were washed with acetone, and the Belzona 1111 carefully was applied by hand leaving very little to be hand sanded once it had cured.
