# BELZONA 5831 KEEPING THE DATA COOL

ID: 9460

## PROBLEM

Corrosion was developing in several cooling tower pans.

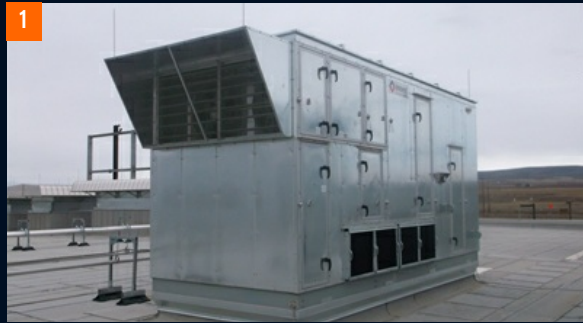
1. The cooling tower.
2. Original condition showing some corrosion.
3. First coat of Belzona 5831 applied with Belzona 9341 Reinforcement Sheet over the seams.
4. Second coat of Belzona 5831 applied, application complete.
