# BELZONA 1341 REFURBISHES A SPIRAL CASING ON A FRANCIS TURBINE

ID: 9462

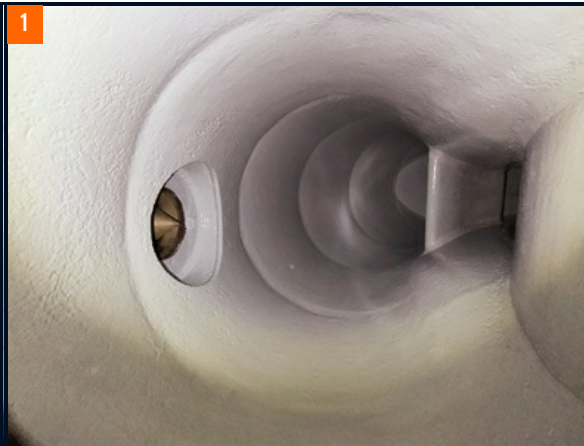
1. Belzona protective coating from around 2006 was due for a refurbishment
2. Spiral casing was grit blasted back to profile, using 2.5 tons of grit.
3. Belzona 1111 was used to reprofile heavily pitted areas prior to coating of Belzona 1341 (Supermetalglide)
4. Two coats of Belzona 1341 (Supermetalglide) was applied to Spiral casing.
