# BELZONA 1321 SOLVES COOLING TOWER HOT WATER BASIN SEAMS LEAK

ID: 9465

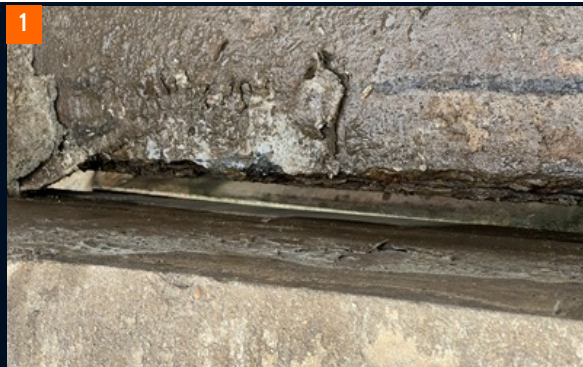
Our client was experiencing multiple leaks from seams on these concrete 4 sided water basins (pools) on top of a large cooling tower.

1. Current Gaps and Damage to Basin Seams
2. Worn out seams on basins
3. Belzona 3121 Applied with Reinforcement Cloth
4. Belzona 3121 Completed

We first cleaned the existing joints and removed peeling material or debris. We proceeded to fill in gap areas with backer rod when needed and then applied a concrete material. (Belzona 4111 was overbudget in this case.)

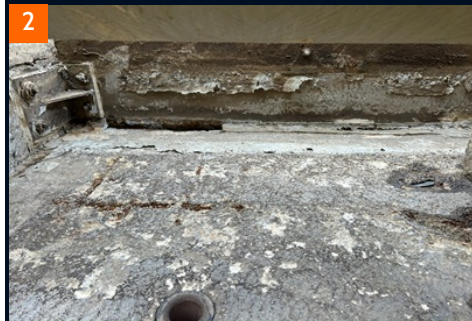
Our client had experienced leaks with his cooling tower water basins. They were very old and due for a sealing to keep them from leaking. Belzona offered a solution of using 3121 and cloth to reinforce these seams.
