# SMOOTH RIDE EXPANSION JOINT

ID: 9469

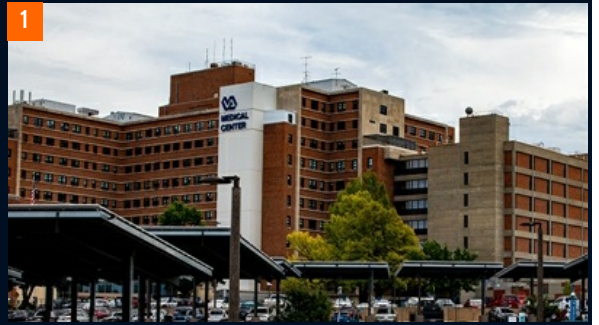
1. Area Veteran's hospital
2. Aluminum cover plate causing bump and trip hazard
3. Plate removed and condition of underlying joint
4. Completely re-engineered and rebuilt smooth ride joint

Diamond grinders and HEPA vacuums were utilized during surface preparation. The Belzona 4131 was hand troweled to ensure the transition was "smooth" and level and top coated with Belzona 4411. The joint was sealed with Belzona 2221.

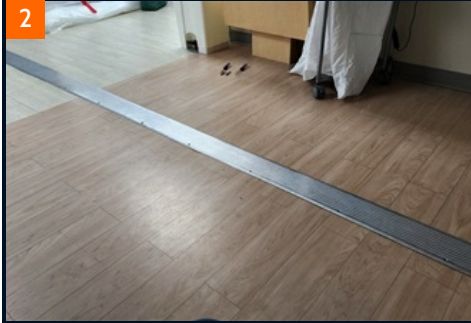
The aluminum cover plate creates an uncomfortable jolt to patients being transported in beds and wheelchairs, as well as a trip hazard for pedestrians.
