# BELZONA SUCESSFULLY RENOVATES PUDDLE PIPES

Corrosion on seawater inlet pipe to cooling system for nuclear power station.

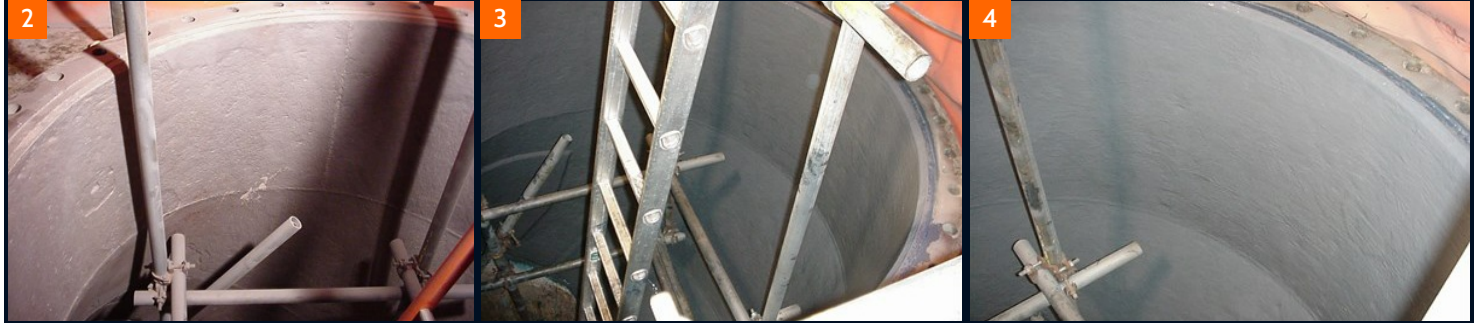
1. Scope of work
2. Grit blasted ready for application
3. Top section complete
4. The finished surface and joint line

Application carried out in accordance with Belzona System Leaflets VPF-1 and VPF-2. A 4-coat system was adopted by the power station to maximise longevity.
