# STAINLESS STEEL VACUUM POTS SEALS

ID: 9470

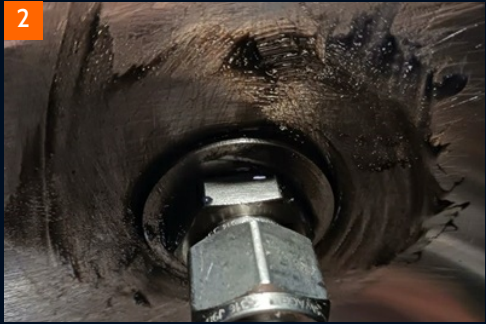
2

1. Stainless-Steel Vacuum Pots
2. Internal Fitting showing seal of Belzona 2311
3. External fitting showing seal of Belzona 2311
4. Vacuum pot fitting complete

The customer removed the fittings and did the pot wall preparation using a 80 grit sanding discs on a grinder and a wire brush onto the fittings. The Belzona 9111 used to clean and degrease the parts, the Belzona 2911 was used on the S/S and than the Belzona 2311 was mixed and applied to all parts than reinstalled, all nuts had been tightened to make the seal and left to cure.
