# WIND FARM TRANSFORMER REPAIR

ID: 9471

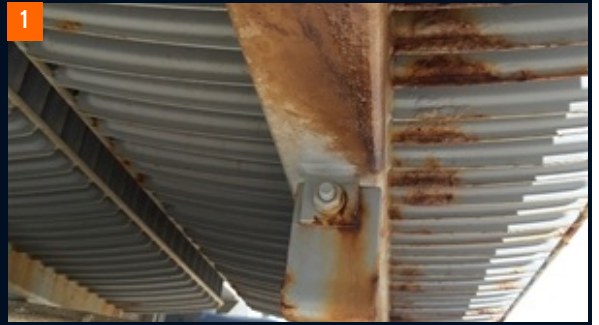
Corrosion and leakage from the cooling channels.

1. Initial condition illustrating rust and leakage.
2. Initial condition illustrating rust.
3. Initial condition illustrating rust and leakage.
4. complete application

Before applying Belzona, the surface was cleaned to get rid of the oil and rust.

Belzona 1161 was used for surface repair in conjunction with Belzona reinforcement sheet 9341.

Belzona 5831 was applied to it for protection following the Belzona 1161 treatment.
