# BELZONA RESTORED THE ERODED TRANSPORT VESSEL TAIL PIPE

ID: 9473

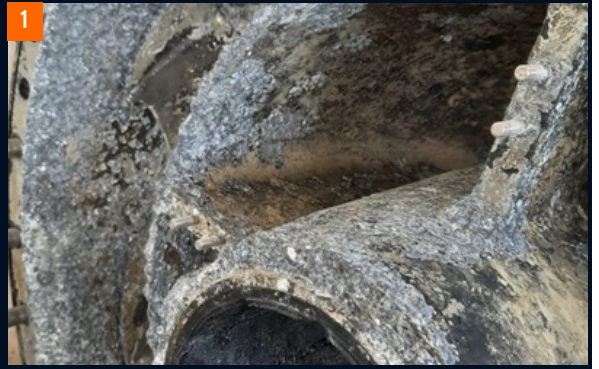
Corrosion-erosion damaged lower half of the tail pipe due to stationary submerged in seawater for 3 years.

1. BEFORE SURFACE PREPARATION SHOWING THE EXTENT OF DAMAGE DUE TO METALLIC EROSION.
2. AFTER SURFACE PREPARATION BY GRIT BLASTING EXPOSING DEEP PITTING AND METAL LOSS.
3. ALL DAMAGED AREA WAS REBUILT USING BELZONA 1311.
4. COMPLETED APPLICATION.

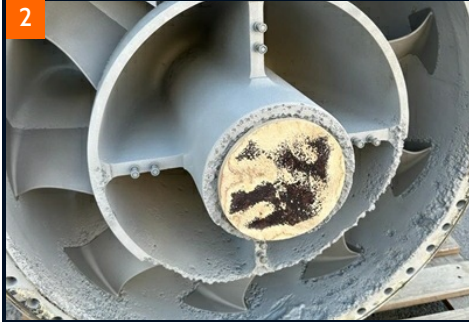
Severe corrosion pitting on lower half of the Tail Pipe which needs to be rebuilt to restore the original state and requires ceramic protective coating for future prevention against erosion attack.
