# BELZONA STRESS CRACK LEAK SEALING AND PLATE BONDING ON EXTERNAL SURFACE OF CRUDE OIL EXPORT PUMP.

ID: 9474

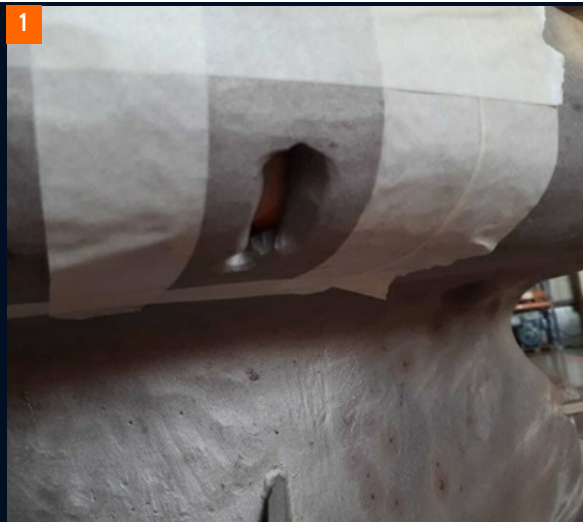
The pump is suffering from leakage due to a combination of tensile stress and a corrosive environment which is the chloride content of the medium.

Leak due to stressed crack line which requires a crack sealing technique and plate bonding.

1. WIDENED CRACK LINE DRILLED ON BOTH ENDS.
2. DRY FITTING OF THE PLATE PRIOR TO HOLE SEALING AND PLATE BONDING
3. COMPLETED PLATE BONDING USING BELZONA 1311
4. TOP COATING COMPLETED FOR FOR THE BONDED PLATE PROTECTION.
