# OFFICE ROOF 5 YEARS OF PROTECTION

ID: 9475

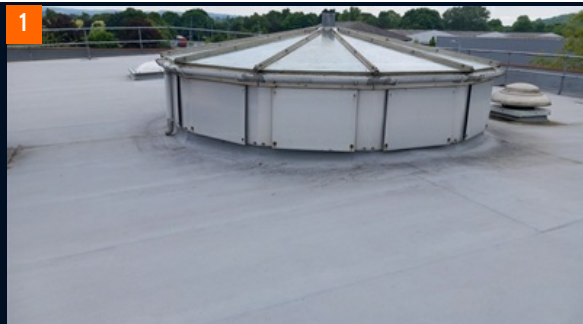
1. Showing no deterioration to applied Belzona 3131 coating
2. Awkward geometry catered for easily with the Belzona 3131 coating
3. A larger expanse of the main roof where the Belzona 3131 was applied
4. An aerial view of the roof showing a fabulous uniform finish, still looking good after 5 years

The important issue was to achieve an effective repair to the roof as an immediate solution. The weather and time of year was an obvious issue, but the Belzona 3131 Winter Grade performed brilliantly and is still showing no signs of deterioration 5 years later
