# BELZONA REPLACES THE DAMAGED COATING OF BRP PUMP

ID: 9479

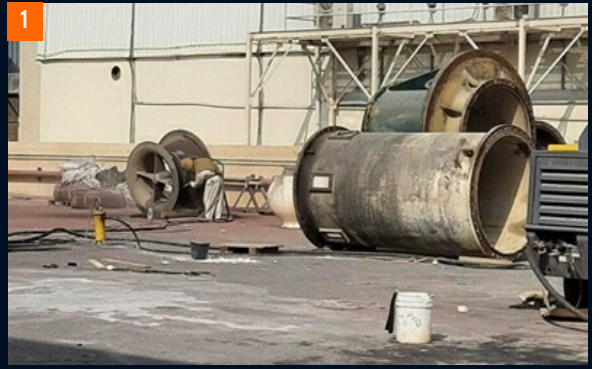
The BRP (Brine Recirculating Pump) was suffering from scattered corrosion due to damage on the existing coating.

1. BRP pump status before surface preparation
2. After surface preparation using grit blasting
3. Application of first and second coat was completed and in this is the completed third coat application.
4. fourth and final coat completed
