# BELZONA PROTECTS THE SEPARATOR FROM ABRASION

ID: 9480

Sichter separator in cement plant.

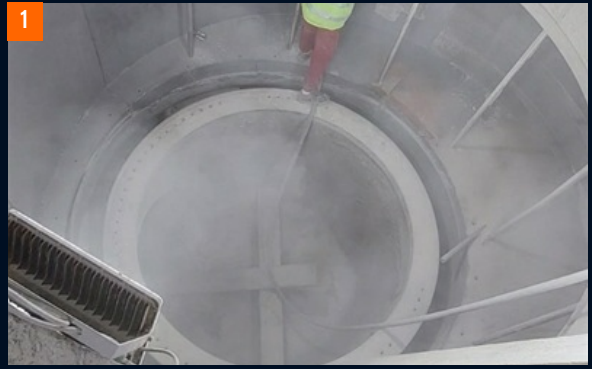
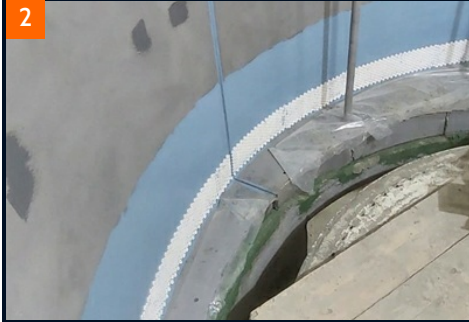
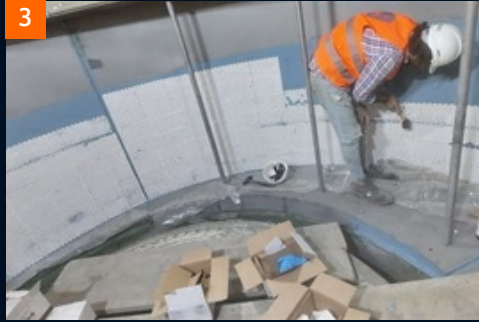
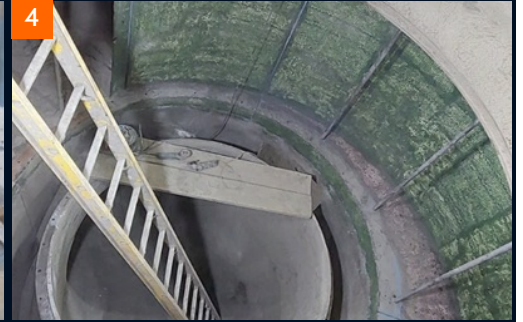
## PHOTOS

The shell of separator suffers from severe abrasion and structural defects in that section would cause safety and operational problems.

1. After Blasting
2. Rebuilding the pitted areas using Belzona 1311 and then applying Belzona 1391T as an adhesive to bond Belzona 9811 Almina Tiles
3. Applying Belzona 9811 Almina Tiles with Belzona 1391T as the adhesive
4. Application completed after applying Belzona 9811 then grouted with Belzona 1813

The application was carried out in accordance with Belzona Know-How system leaflet SHM-7.
